# ENVIRONMENTAL ASSESSMENT

THE FOURTH AVENUE GAMBELL  
ANCHORAGE, ALASKA

*EnviroAmerica, Incorporated*  
Anchorage, Alaska

January 29, 1993

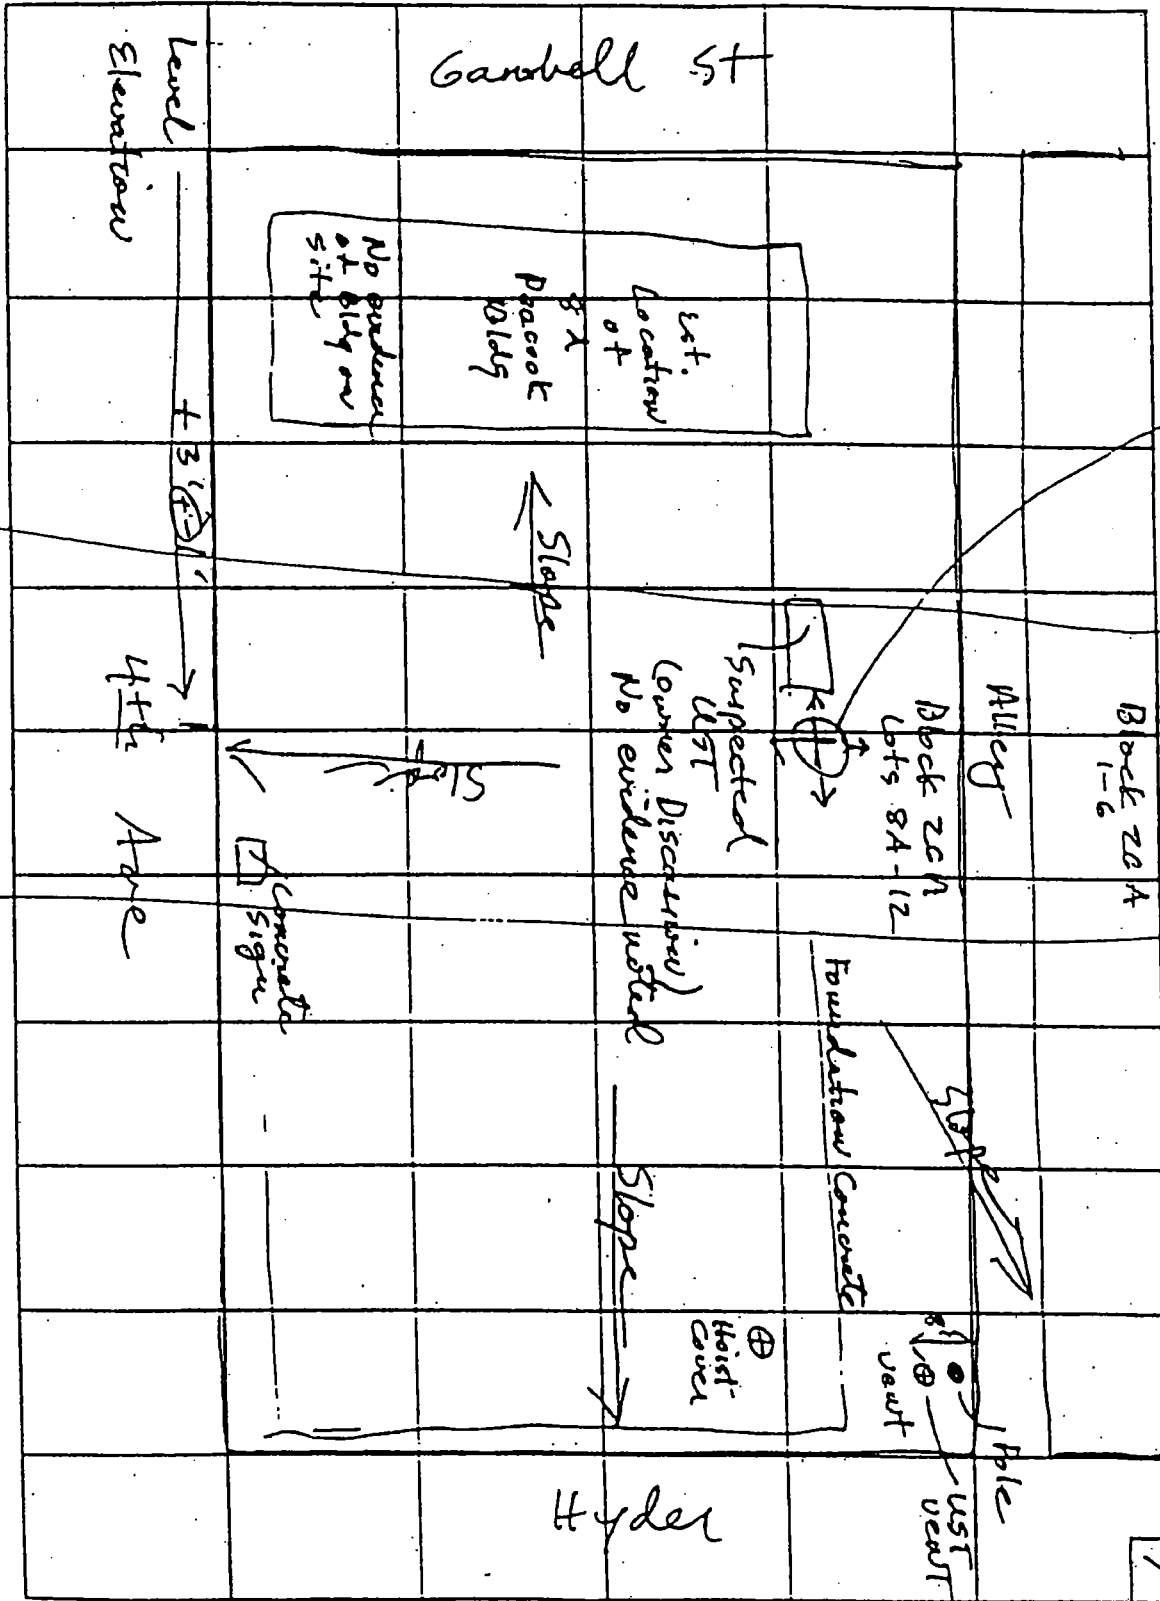
Site Sketch

Slope High Point  
Lot 2

Water Disposal

One vent pipe noted - W of Lot 12 - 8ft S. of  
alley - Went to pole. Client indicates other tanks  
may be present on site  
⊗ Hoist lift noted. Covered with steel covers.  
In Lot 11 approximately 30' S of alley - See sketch

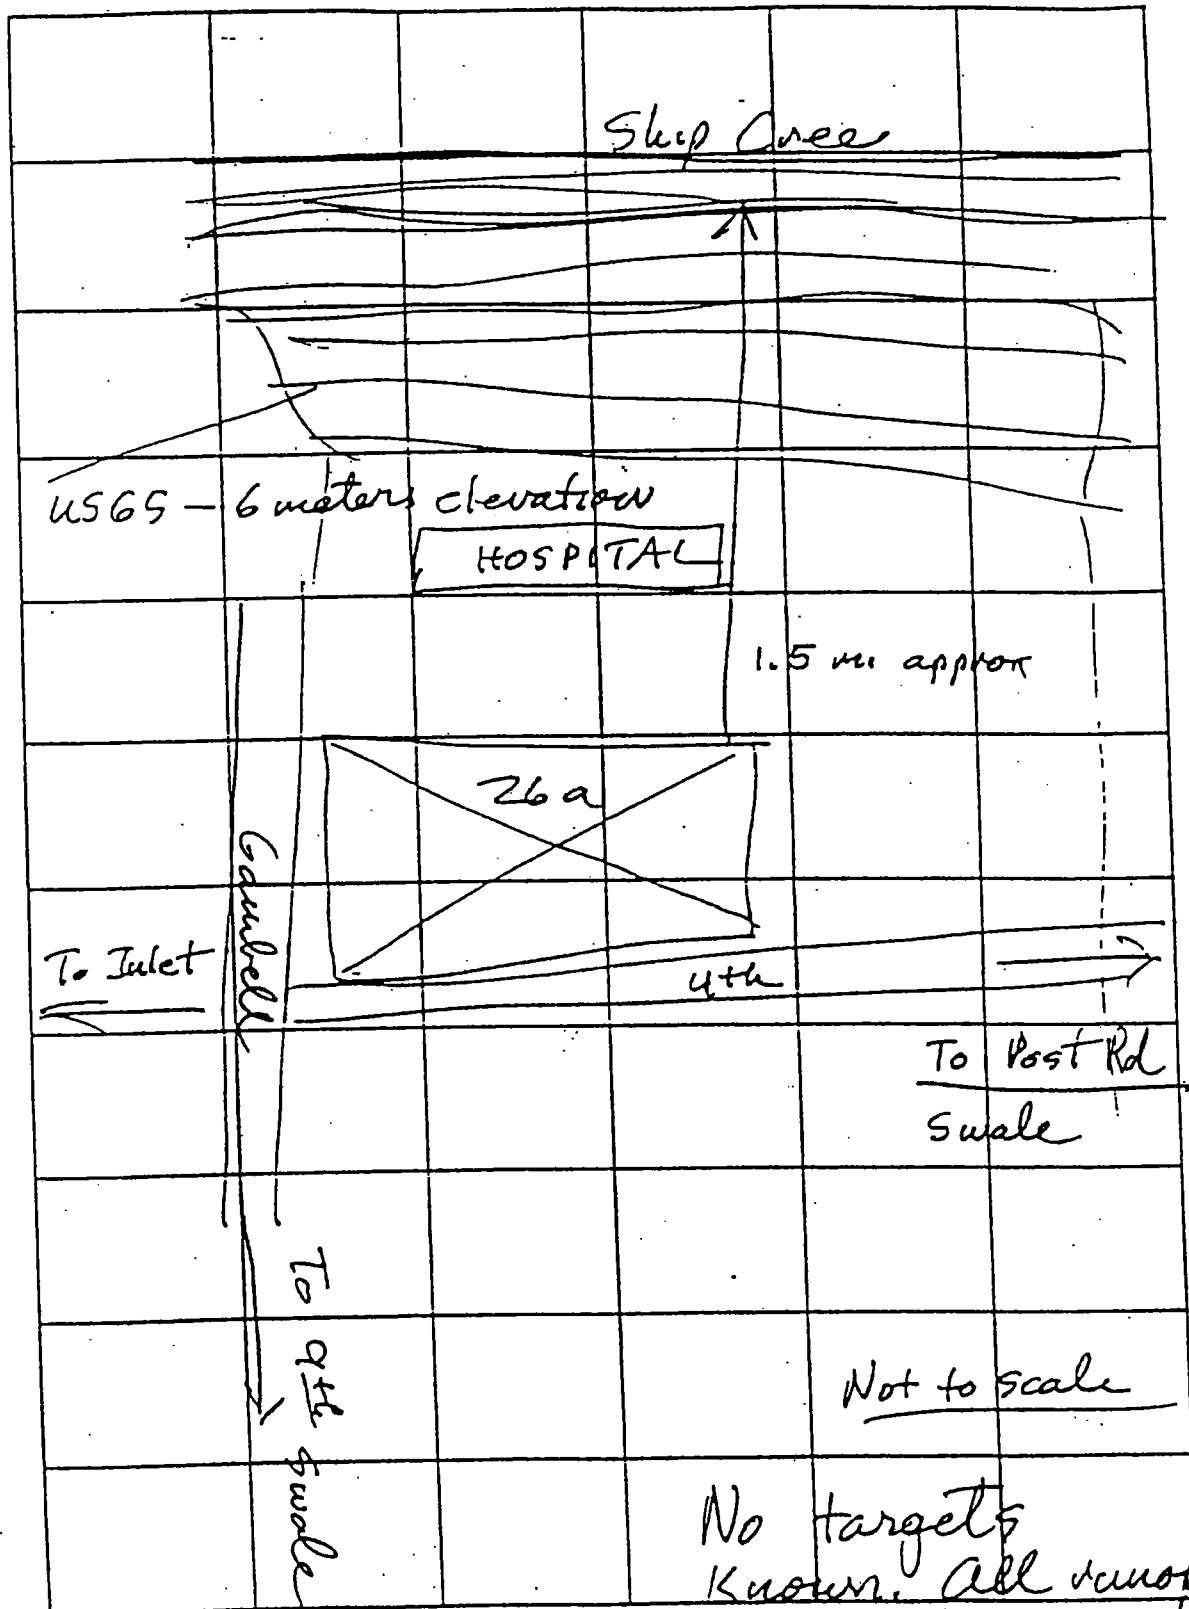
Surface Water Sketch

No targets  
Known. All runoff  
via drains.  
Good H<sub>2</sub>O link.
